Gordon Playground
Inspections LTD **PSSLive+**

Annual Inspection 2023

Townwell Play Area

Cromhall Parish Council

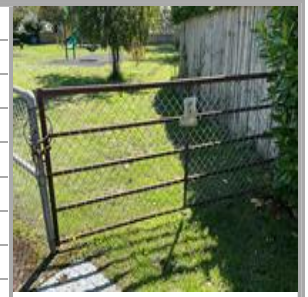
Gate Maintenance - Finding

Asset	Gate Maintenance
Finding Group	Maintenance
Finding Title	Item - Rusting in places
Standard Reference	
Standard Description	Item is rusting in places
Finding Notes	
Cause	Wear and Tear
Finding Creation Date	09/08/2023 13:10:34
Risk Value Text	1 x 1 = 1
Risk Level	Very Low
Resolve By Date	08/08/2024 13:10:44
Finding Status	Open

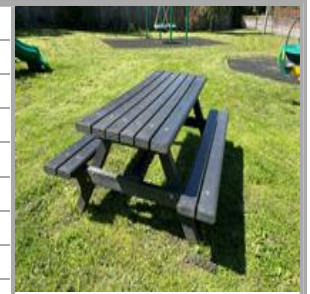
Picnic Table (Plastic) - Finding

Asset	Picnic Table (Plastic)
Finding Group	Maintenance
Finding Title	Ground Eroded
Standard Reference	
Standard Description	Ground eroded
Finding Notes	
Cause	Wear and Tear
Finding Creation Date	09/08/2023 13:16:23
Risk Value Text	1 x 2 = 2
Risk Level	Very Low
Resolve By Date	24/01/2024 12:16:36
Finding Status	Open

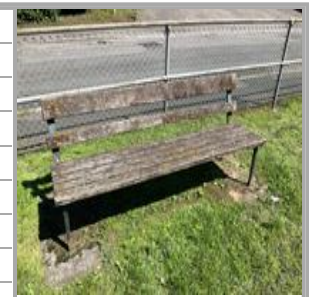
Asset	Bench Seat x2
Finding Group	Maintenance
Finding Title	Fixtures - Loose or Missing
Standard Reference	
Standard Description	Fixtures loose or missing
Finding Notes	Both seats
Cause	Wear and Tear
Finding Creation Date	08/07/2020 10:48:00
Risk Value Text	1 x 2 = 2
Risk Level	Very Low
Resolve By Date	07/01/2021 10:48:00
Finding Status	Open

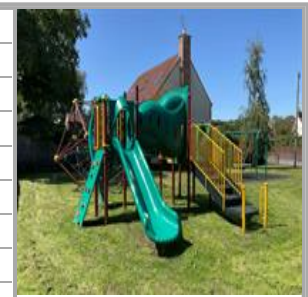
Asset	Multiplay Unit Junior
Finding Group	Maintenance
Finding Title	Item - Loose in Ground
Standard Reference	
Standard Description	Loose in ground
Finding Notes	Green plastic climber element
Cause	Wear and Tear
Finding Creation Date	25/07/2022 09:17:00
Risk Value Text	1 x 3 = 3
Risk Level	Very Low
Resolve By Date	25/07/2023 09:17:00
Finding Status	Open

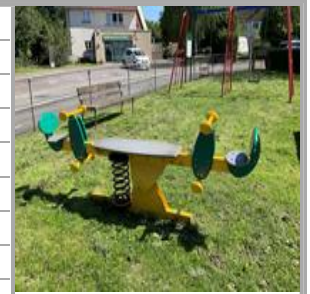
Rocker - Double - Findings

Asset	Rocker - Double
Finding Group	Maintenance
Finding Title	Fixtures - Loose or Missing
Standard Reference	
Standard Description	Fixtures loose or missing
Finding Notes	
Cause	Wear and Tear
Finding Creation Date	08/07/2020 10:48:00
Risk Value Text	3 x 3 = 9
Risk Level	Low
Resolve By Date	08/08/2020 10:48:00
Finding Status	Closed

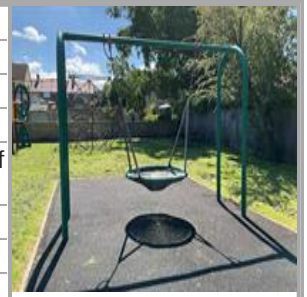
Swing - 1 Bay Basket Swing - Findings

Asset	Swing - 1 Bay Basket Swing
Finding Group	BS EN 1176:2017 Part 2 (Swings - Playground)
Finding Title	Ground Clearance - Group-Use Seat
Standard Reference	EN 1176:2017 - 2 - 4.2
Standard Description	The ground clearance under the swing seat is less than the minimum permitted of 400mm.
Finding Notes	
Cause	Installation Defect
Finding Creation Date	08/07/2020 10:48:00
Risk Value Text	2 x 4 = 8
Risk Level	Low
Resolve By Date	08/10/2020 10:48:00
Finding Status	Closed
