Gordon Playground
Inspections LTD **PSSLive+**

Annual Inspection 2023

Townwell Play Area

Cromhall Parish Council

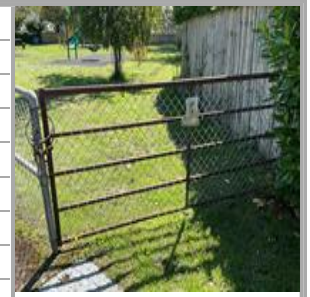
Gate Maintenance - Finding

Asset	Gate Maintenance
Finding Group	Maintenance
Finding Title	Item - Rusting in places
Standard Reference	
Standard Description	Item is rusting in places
Finding Notes	
Cause	Wear and Tear
Finding Creation Date	09/08/2023 13:10:34
Risk Value Text	1 x 1 = 1
Risk Level	Very Low
Resolve By Date	08/08/2024 13:10:44
Finding Status	Open

Item - Rusting in places - Task

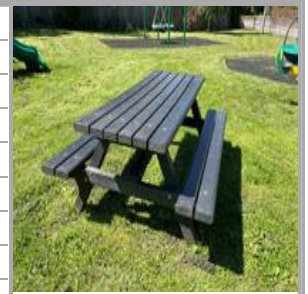
Picnic Table (Plastic) - Finding

Asset	Picnic Table (Plastic)
Finding Group	Maintenance
Finding Title	Ground Eroded
Standard Reference	
Standard Description	Ground eroded
Finding Notes	
Cause	Wear and Tear
Finding Creation Date	09/08/2023 13:16:23
Risk Value Text	1 x 2 = 2
Risk Level	Very Low
Resolve By Date	24/01/2024 12:16:36
Finding Status	Open

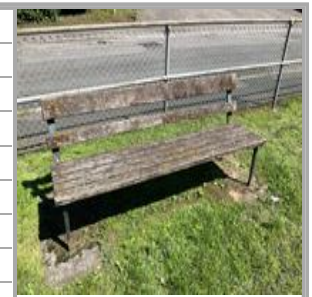
Asset	Bench Seat x2
Finding Group	Maintenance
Finding Title	Item - Requires cleaning
Standard Reference	
Standard Description	The equipment is dirty or algae covered
Finding Notes	
Cause	Wear and Tear
Finding Creation Date	25/07/2022 09:17:00
Risk Value Text	1 x 1 = 1
Risk Level	Very Low
Resolve By Date	25/07/2022 09:17:00
Finding Status	Open

Task Title	Clean Item
Task Notes	
Task Status	Unapproved

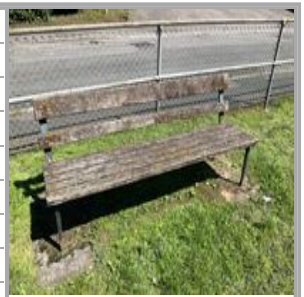
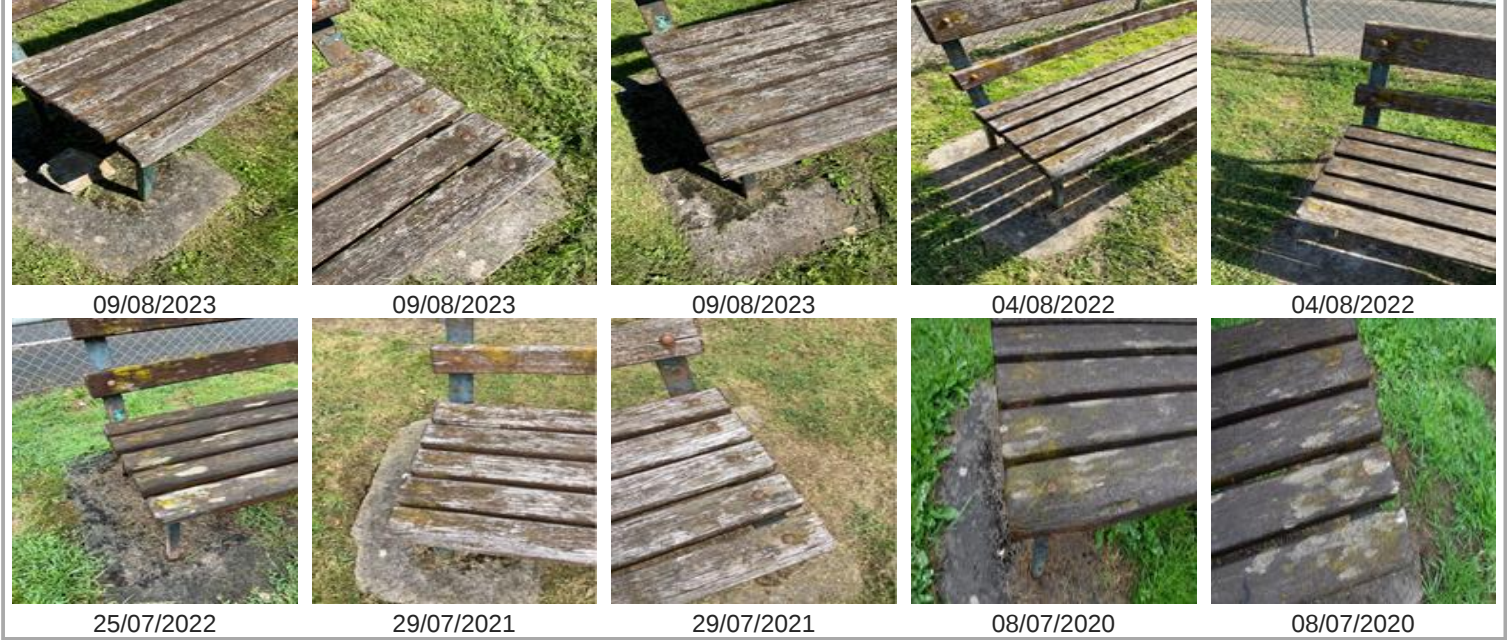
Asset	Bench Seat x2
Finding Group	Maintenance
Finding Title	Fixtures - Loose or Missing
Standard Reference	
Standard Description	Fixtures loose or missing
Finding Notes	Both seats
Cause	Wear and Tear
Finding Creation Date	08/07/2020 10:48:00
Risk Value Text	1 x 2 = 2
Risk Level	Very Low
Resolve By Date	07/01/2021 10:48:00
Finding Status	Open

Task Title	Tighten loose fixtures & fittings
Task Notes	
Task Status	Unapproved

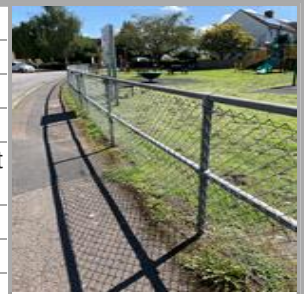
Fence Wire Mesh - Finding

Asset	Fence Wire Mesh
Finding Group	BS EN 1176:2017 Part 1 (General - Playground)
Finding Title	Finish - Bolts Protruding
Standard Reference	EN 1176:2017 - 1 - 4.2.5
Standard Description	There are bolt threads protruding within the accessible parts of the equipment that are not permanently covered (e.g. dome headed nuts).
Finding Notes	
Cause	Installation Defect
Finding Creation Date	08/07/2020 10:48:00
Risk Value Text	2 x 2 = 4
Risk Level	Low
Resolve By Date	08/10/2020 10:48:00
Finding Status	Open

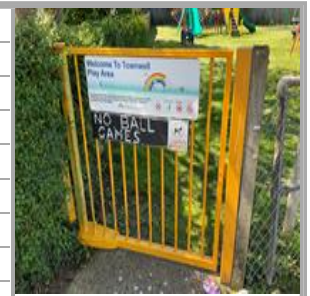
Gate Pedestrian - Finding

Asset	Gate Pedestrian
Finding Group	Maintenance
Finding Title	Gate - Self-Closing - Adjustment
Standard Reference	
Standard Description	Self-closing gate does not function correctly
Finding Notes	Gate stands ajar
Cause	Wear and Tear
Finding Creation Date	08/07/2020 10:48:00
Risk Value Text	1 x 2 = 2
Risk Level	Very Low
Resolve By Date	08/10/2020 10:48:00
Finding Status	Open

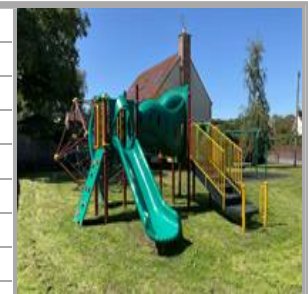
Multiplay Unit Junior - Findings

Asset	Multiplay Unit Junior
Finding Group	Maintenance
Finding Title	Item - Requires cleaning
Standard Reference	
Standard Description	The equipment is dirty or algae covered
Finding Notes	
Cause	Wear and Tear
Finding Creation Date	25/07/2022 09:17:00
Risk Value Text	1 x 1 = 1
Risk Level	Very Low
Resolve By Date	25/01/2023 09:17:00
Finding Status	Open

Task Title	Clean Item
Task Notes	
Task Status	Unapproved

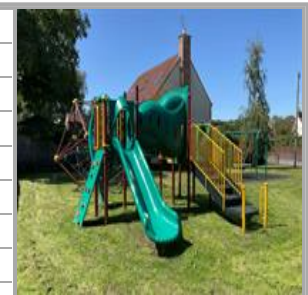
Asset	Multiplay Unit Junior
Finding Group	Maintenance
Finding Title	Item - Loose in Ground
Standard Reference	
Standard Description	Loose in ground
Finding Notes	Green plastic climber element
Cause	Wear and Tear
Finding Creation Date	25/07/2022 09:17:00
Risk Value Text	1 x 3 = 3
Risk Level	Very Low
Resolve By Date	25/07/2023 09:17:00
Finding Status	Open

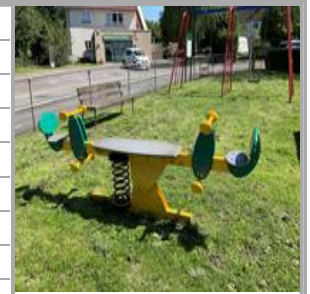
Rocker - Double - Findings

Asset	Rocker - Double
Finding Group	Maintenance
Finding Title	Item - Bearings Worn
Standard Reference	
Standard Description	The bearings are worn
Finding Notes	09.08.23 Condition deteriorated
Cause	Wear and Tear
Finding Creation Date	25/07/2022 09:17:00
Risk Value Text	2 x 3 = 6
Risk Level	Low
Resolve By Date	01/11/2023 12:26:25
Finding Status	Open

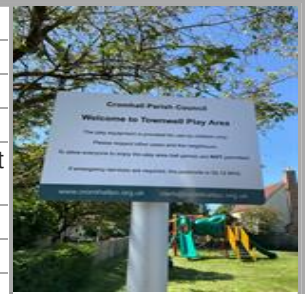
Signage - Findings

Asset	Signage
Finding Group	BS EN 1176:2017 Part 1 (General - Playground)
Finding Title	Finish - Bolts Protruding
Standard Reference	EN 1176:2017 - 1 - 4.2.5
Standard Description	There are bolt threads protruding within the accessible parts of the equipment that are not permanently covered (e.g. dome headed nuts).
Finding Notes	
Cause	Installation Defect
Finding Creation Date	08/07/2020 10:48:00
Risk Value Text	2 x 2 = 4
Risk Level	Low
Resolve By Date	08/10/2020 10:48:00
Finding Status	Open

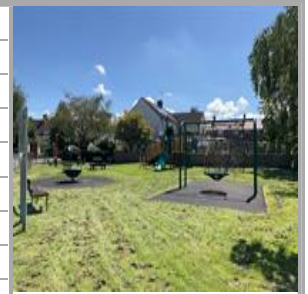
Site - Townwell Play Area Cromhall - Findings

Asset	Site - Townwell Play Area Cromhall
Finding Group	Maintenance
Finding Title	Surface - Trip points
Standard Reference	
Standard Description	Trip points
Finding Notes	
Cause	Wear and Tear
Finding Creation Date	08/07/2020 10:48:00
Risk Value Text	2 x 3 = 6
Risk Level	Low
Resolve By Date	23/10/2020 14:34:00
Finding Status	Open

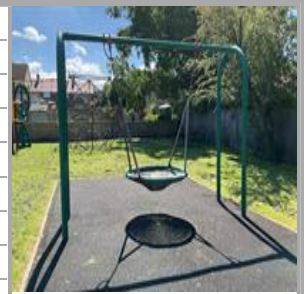
Swing - 1 Bay Basket Swing - Findings

Asset	Swing - 1 Bay Basket Swing
Finding Group	Maintenance
Finding Title	Item - Damaged
Standard Reference	
Standard Description	Item is damaged
Finding Notes	Chain covers
Cause	Wear and Tear
Finding Creation Date	25/07/2022 09:17:00
Risk Value Text	1 x 3 = 3
Risk Level	Very Low
Resolve By Date	25/07/2023 09:17:00
Finding Status	Open

Task Title	Monitor
Task Notes	
Task Status	Unapproved

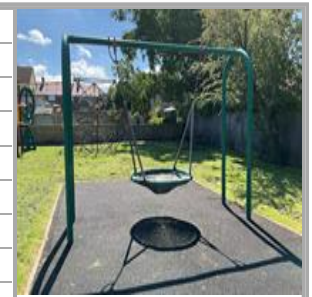
Asset	Swing - 1 Bay Basket Swing
Finding Group	BS EN 1176:2017 Part 1 (General - Playground)
Finding Title	Entrapment - Finger
Standard Reference	EN 1176:2017 - 1 - 4.2.7.6
Standard Description	When tested in accordance with EN 1176 a finger entrapment is present.
Finding Notes	
Cause	Manufacturer Defect
Finding Creation Date	08/07/2020 10:48:00
Risk Value Text	1 x 4 = 4
Risk Level	Low
Resolve By Date	08/07/2021 10:48:00
Finding Status	Open

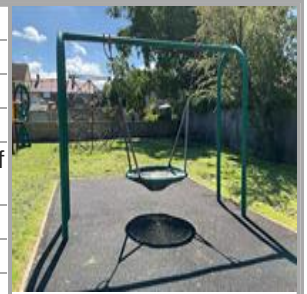
Swing - 1 Bay Basket Swing - Findings

Asset	Swing - 1 Bay Basket Swing
Finding Group	BS EN 1176:2017 Part 2 (Swings - Playground)
Finding Title	Ground Clearance - Group-Use Seat
Standard Reference	EN 1176:2017 - 2 - 4.2
Standard Description	The ground clearance under the swing seat is less than the minimum permitted of 400mm.
Finding Notes	
Cause	Installation Defect
Finding Creation Date	08/07/2020 10:48:00
Risk Value Text	2 x 4 = 8
Risk Level	Low
Resolve By Date	08/10/2020 10:48:00
Finding Status	Closed
